Analisa Penyebab Terjadinya Alarm Pada Modul Receiver Unit (RU) 7-12 Peralatan Multilateration di PERUM LPPNPI Cabang Surabaya

This research aims to analyze damage to one of the Multilateration equipment (MLAT) modules which causes a red alarm on the Receiver Unit (RU) monitor. Multilateration (MLAT) is equipment used to accurately determine target positions at airports so that Multilateration (MLAT) equipment is required to operate normally so that it can help the Air Traffic Controller (ATC) in guiding flights. In this research, one of the Multilateration equipment (MLAT) modules was damaged. So that equipment performance decreases and causes a readable alarm condition. The research method used in this research is Literature Study.

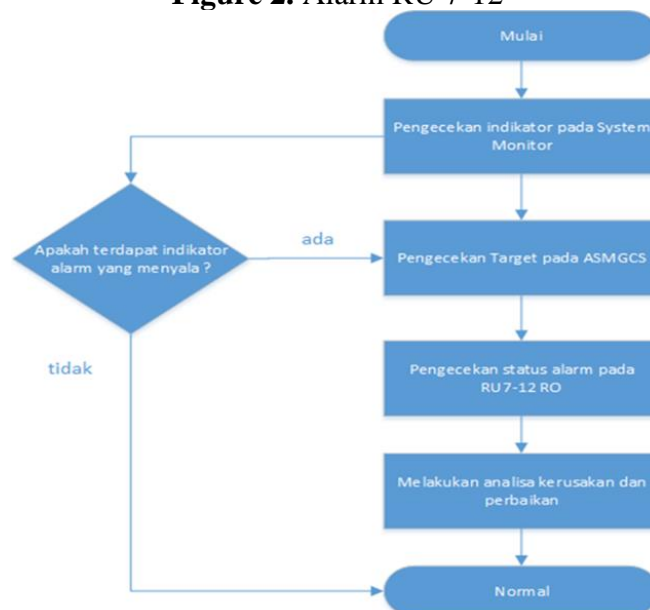
Figure 3. alarm checking flow chart

Analysis of the alarm checks that the author conveyed during the problem resulted in several points as follows, including:

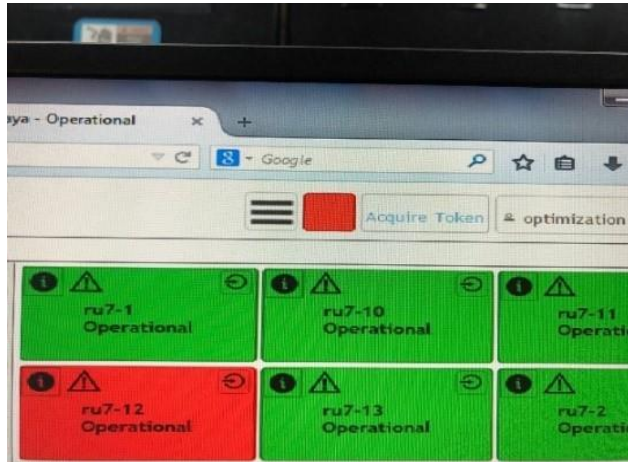
Figure 4. RU display in System Monitor

1. Before checking the RU 7-12 panel outdoors, check the MLAT System Monitor.

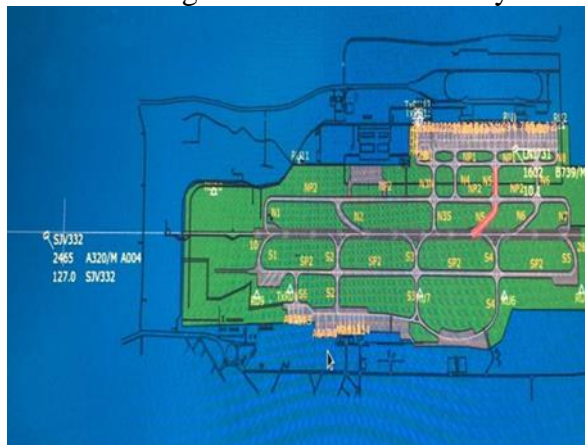
Figure 5. Target Detected at TRADIS ASMGCS

2. Select the RU that is indicated as an error with a red alarm indicator on the system monitor display. Then check the Traffic Display (TRADIS) at ASMGCS to ensure that the aircraft target remains monitored by other RU.

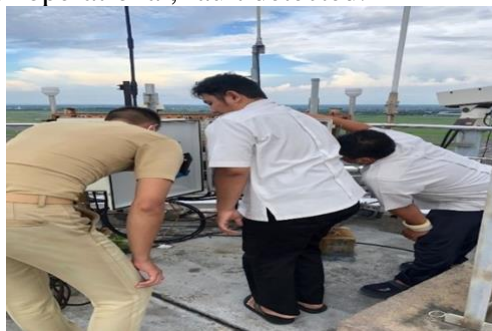
Figure 6. Checking RU Panel 7-12

3. Then a direct check was carried out on the RU7-12 panel on the rooftop of the Surabaya Airnav Tower and it was found that the Receiver Only Module LED was flashing red or operational, fault detected.

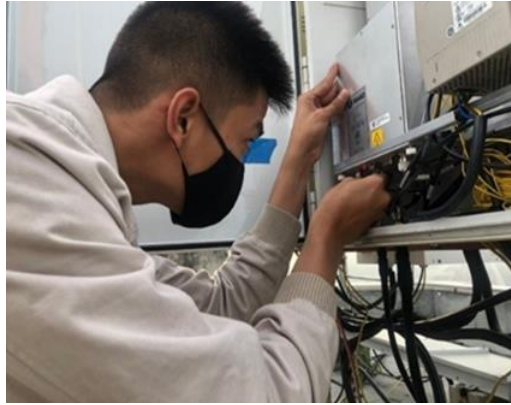
Figure 8. Process troubleshooting

1. Check the MLAT data communication line, check the UPS panel and measure the input voltage on the UPS panel at the outdoor Airnav Tower Surabaya for the MLAT RU7-12 RO panel. The result is that the Power Supply voltage for the panel is normal and the UPS is ON.
2. Then troubleshooting was carried out on RU7-12 on the rooftop of the Surabaya Airnav Tower by carrying out experiments on replacing spare parts for the RU module. After replacing the module, the RU7-12 Module LED indicator was flashing Alternating red/green or was in maintenance mode.

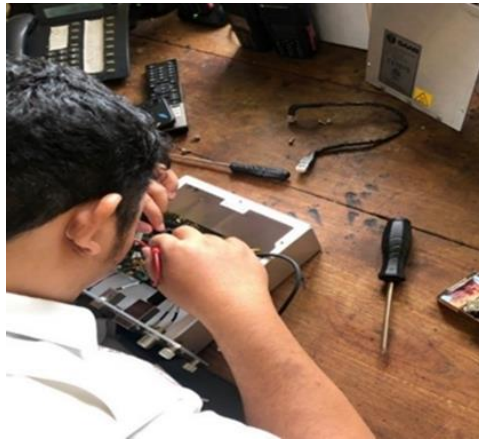
Figure 9. Advanced troubleshooting process

3. On June 12 2022, further troubleshooting was carried out, namely checking the module components and attempting to replace the SD card from the old module to the new module. It was found that RU 7-12 was still experiencing an alarm.
